EVIDENCE BOOK

Infection Control

DualDefense™

Proprietary Infection Control by NSK

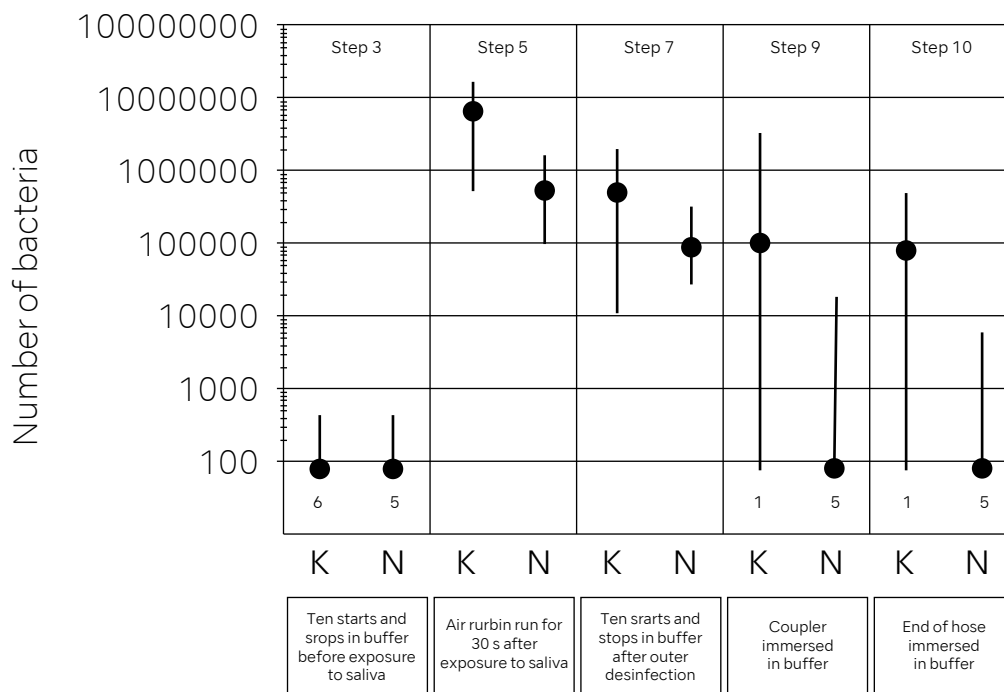
[Fig. 2.] The number of bacteria emitted from high-speed air-driven handpieces before and after exposure to saliva. Three Kavo Super-Torque 630B (K) and three NSK Phatelus-II (N) were tested three times. Median number and range of values are given. The number of tests in which <100 bacteria were detected is indicated in the figure. The bacteria were grown for 2 days on blood agar in an atmosphere of air with 5% carbon dioxide.

There were few contaminating bacteria on the equipment before the head of the handpiece was exposed to saliva (Step 1, 2, and 3, Fig. 1; Table 1). No salivary streptococci were detected on the coupler. On the connecting end of the hose one colony of *Streptococcus salivarius* was detected on one out of 18 occasions. The handpiece did not emit any salivary streptococci, when the head was submerged into buffer solution and the air turbin was started and stopped 10 times (Step 3, Fig 1; Fig. 2 and Table 1).

After the handpiece had been exposed to saliva (step 4, Fig. 1) and the air turbin of the handpiece was run over the surface of the buffer (step 5, Fig. 1; Fig. 2 and Table 1),

10^6 to 10^7 bacteria left the Kavo handpiece, and
 10^5 to 10^6 bacteria left the NSK handpiece.

After the handpiece was wiped with isopropyl alcohol, the head submerged into buffer, and the air turbin of the handpiece was started and stopped 10 times (step 7, Fig. 1; Fig 2 and Table 1),

10^5 to 10^6 bacteria left the Kavo handpiece, and
 10^4 to 10^5 bacteria left the NSK handpiece.

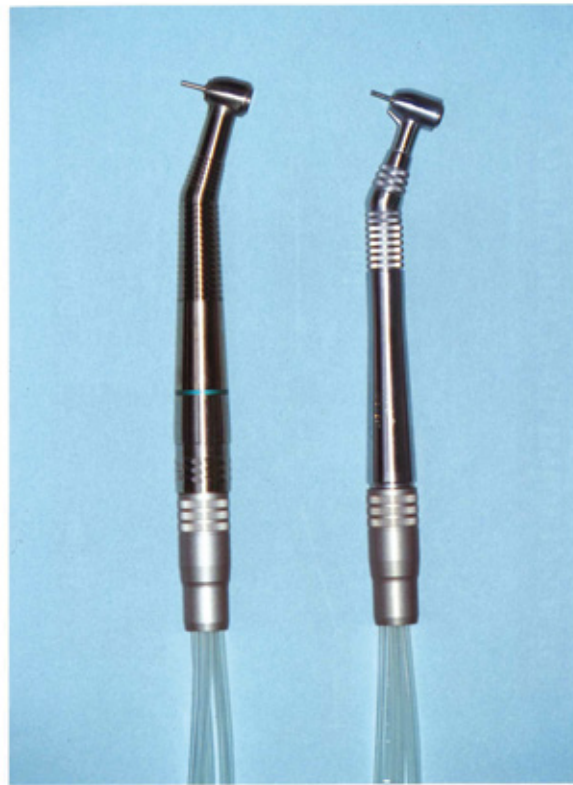
[Fig. 3] Handpieces tested left: new type handpiece with the Labyrinth right: conventional handpiece

The new handpiece with the Labyrinth (Fig . 3 left) and a conventional handpiece (fig. 3 right) were tested in this study.

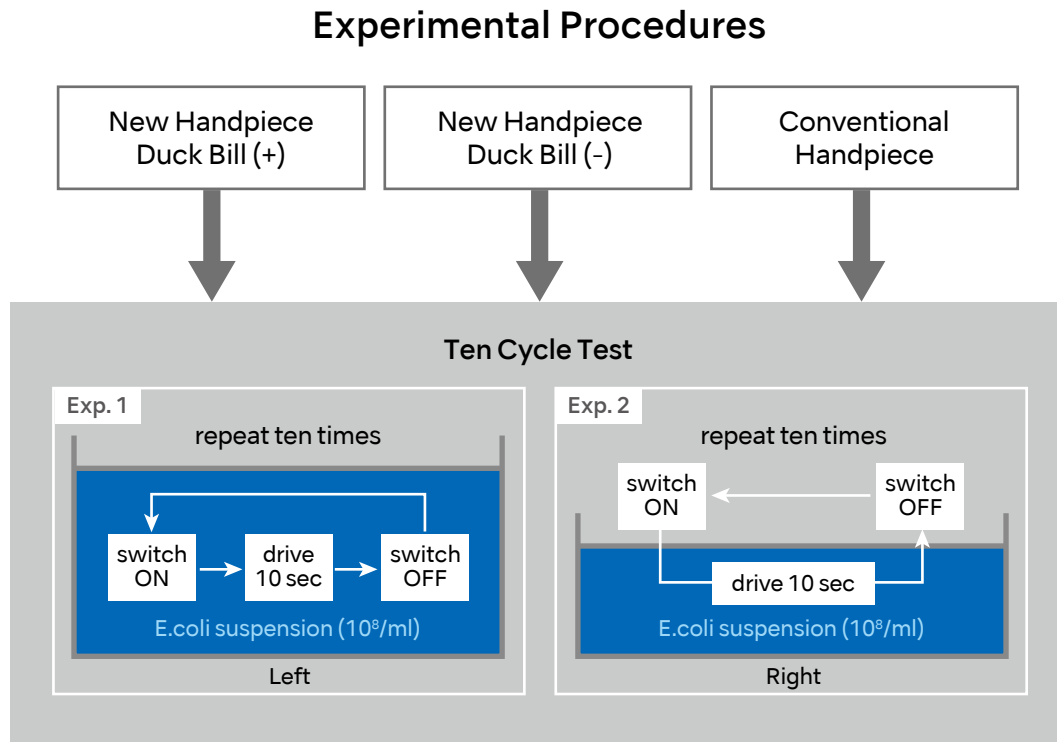
[Fig. 5] Experimental Procedures

In the first experiment (Fig. 5 left), the head of each handpiece was dipped in E.coli-saline suspension, after which the turbine was run for 10 seconds, and switched off. The head was kept in the suspension for 10 seconds. This cycle was repeated ten times per test.

In the second experiment (Fig. 5 right), the unit was run while the head was dipped in suspension, then removed from the solution before switching the turbine off. This cycle was also repeated ten times.
